**Flood Control Project Maintenance  
Levee Inspections**  
**LMA District Cover Sheet**  
**Spring 2017 Levee Inspection Results**

**Reclamation District No. 0017 Mossdale**

**Levee Inspection Report By Mile - Spring 2017**

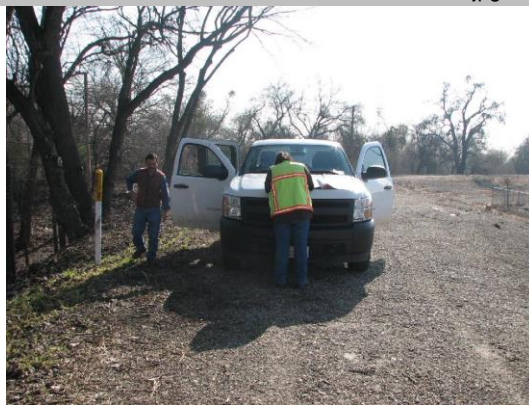
Photo 2 of 3 : UCIP\_SP\_2017\_40603\_38479.jpg

View of levee crown at crossing. Marker for line visible on waterward shoulder.

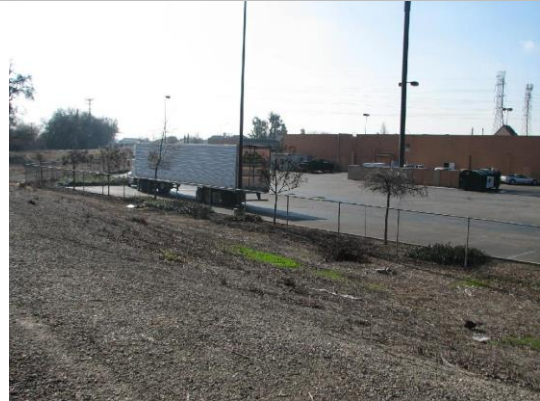
Photo 3 of 3 : UCIP\_SP\_2017\_40603\_38478.jpg

LM Start	0.03	Rating **	M	Issue No.	12 (cont)	
LM End	0.03	Issue Type +	En	Location *	WS	
Category	Supplemental			GPS Latitude/Longitude		
				Start		End
Item	DWR UCIP Field Study			37.911561 °		37.911561 °
				-121.291441 °		-121.291441 °
DWR ID						
Comment Code						
Inspector Comment						
FS_ID:40603 DS_ID:1 EP_NO: 6623 Repair Type: Non-Urgent Crossing Status: Found UCIP Comments: Marker missing on landward side. Need to contact owner to determine status of crossing. Need date of last inspection and confirmation that crossing is still in operable condition. FIELD_STRUCT_DESC: 5-inch diameter welded steel natural gas pipeline through the levees, 4.5 feet below the crown, across the channels and overflow area. (Permit No. 6623-1969) FS Date: 2/3/2010

View of landward side.

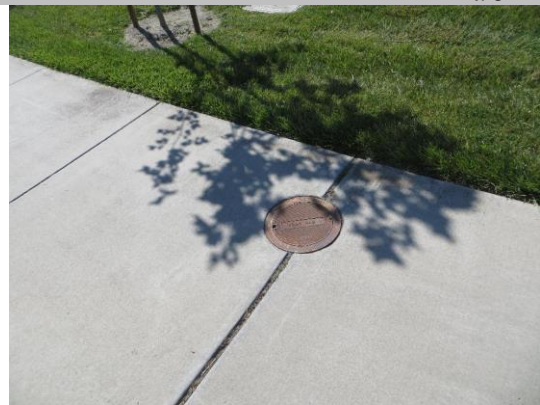
Photo 1 of 3 : UCIP\_SP\_2017\_49990\_74222.jpg

Comment Code					
Inspector Comment					
FS_ID:49990 DS_ID:72 EP_NO: 15185 Repair Type: Urgent Crossing Status: Indicator Found UCIP Comments: 7/12/2016 No markers (no photos taken in 2016). Need to contact owner to determine status of crossing. If crossing is active, owner will need to coordinate with CVFPB to install markers to comply with Title 23. (DWR UCIP - omagana)5/19/2015 Need to install gasline markers. (DWR UCIP - omagana) FIELD_STRUCT_DESC: 8-inch soil proofed steel gas main through the left bank levee and under the channel of French Camp Slough. The pipeline has a minimum cover of 20 to 25 feet within the overflow areas and under the channel. (Permit No. 15185, 1989 - Pacific Gas & Electric Company [PG&E]) FS Date: 7/12/2016

Gas access lid in sidewalk Approximately 200-feet to west of crown.

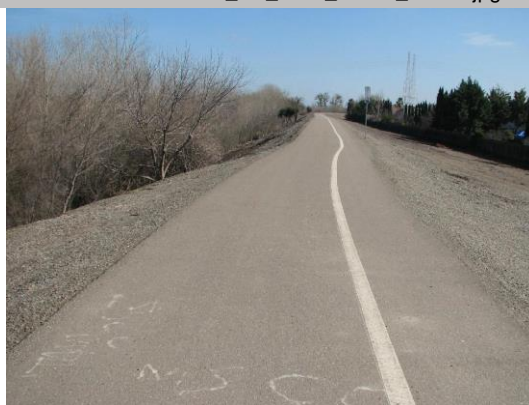
Photo 1 of 3 : UCIP\_SP\_2017\_40604\_38491.jpg

LM Start	1.31	Rating **	M	Issue No.	14
LM End	1.31	Issue Type +	En	Location *	WS
Category	Supplemental			GPS Latitude/Longitude	
				Start	End
Item	DWR UCIP Field Study			37.915928 °	37.915928 °
				-121.312471 °	-121.312471 °
DWR ID					
Comment Code					
Inspector Comment					
FS_ID:40604 DS_ID:2 EP_NO: 14992 Repair Type: Non-Urgent Crossing Status: Indicator Found UCIP Comments: Need to contact owner to determine status of crossing. Also need date of last inspection. FIELD_STRUCT_DESC: 1 of 3. 30-inch diameter HDPE sewer force main (SFM). All pipes encased in concrete at approximately 32 feet below levee crown. (Permit No. 14992-1989) FS Date: 2/3/2010

Overview of levee crown at crossing.

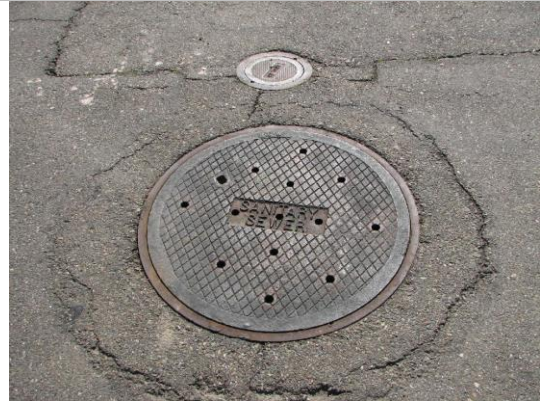
Photo 3 of 3 : UCIP\_SP\_2017\_40605\_38509.jpg

LM Start	1.31	Rating **	M	Issue No.	15 (cont)	
LM End	1.31	Issue Type +	En	Location *	WS	
Category	Supplemental			GPS Latitude/Longitude		
				Start		End
Item	DWR UCIP Field Study			37.915928 °		37.915928 °
				-121.312471 °		-121.312471 °
DWR ID						
Comment Code						
Inspector Comment						
FS_ID:40605						
DS_ID:159						
EP_NO: 14992						
Repair Type: Non-Urgent						
Crossing Status: Indicator Found						
UCIP Comments: Need to contact owner to determine status of crossing. Also need date of last inspection.						
FIELD_STRUCT_DESC: 2 of 3. A 30-inch diameter HDPE sewer force main (SFM). All pipes encased in concrete at approximately 32 feet below levee crown. (Permit No. 14992-1989)						
FS Date: 2/3/2010

Manhole for sanitary sewer visible on landward side.

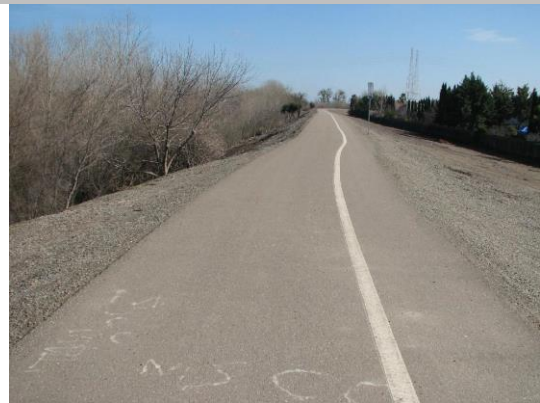
Photo 1 of 3 : UCIP\_SP\_2017\_40606\_71942.jpg

LM Start	1.31	Rating **	M	Issue No.	16	
LM End	1.31	Issue Type +	En	Location *	WS	
Category	Supplemental			GPS Latitude/Longitude		
				Start		End
Item	DWR UCIP Field Study			37.915928 °		37.915928 °
				-121.312471 °		-121.312471 °
DWR ID						
Comment Code						
Inspector Comment						
FS_ID:40606 DS_ID:158 EP_NO: 14992 Repair Type: Non-Urgent Crossing Status: Indicator Found UCIP Comments: Need to contact owner to determine status of crossing. Also need date of last inspection. FIELD_STRUCT_DESC: 3 of 3. A 12-inch diameter HDPE sewer force main (SFM). All pipes encased in concrete at approximately 32 feet below levee crown. (Permit No. 14992-1989) FS Date: 2/3/2010

View of levee crown at crossing.

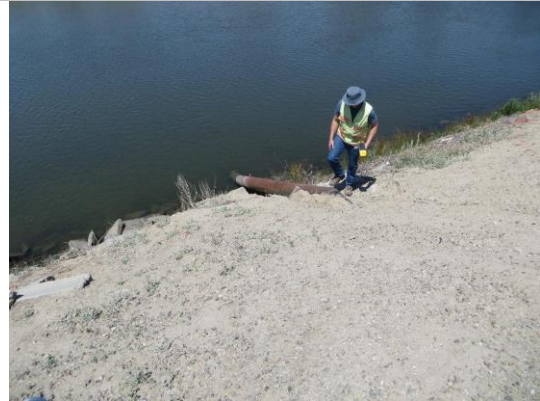
Photo 1 of 3 : UCIP\_SP\_2017\_49640\_74436.jpg

(2015) Damage pipe section located on WS toe has been replaced.

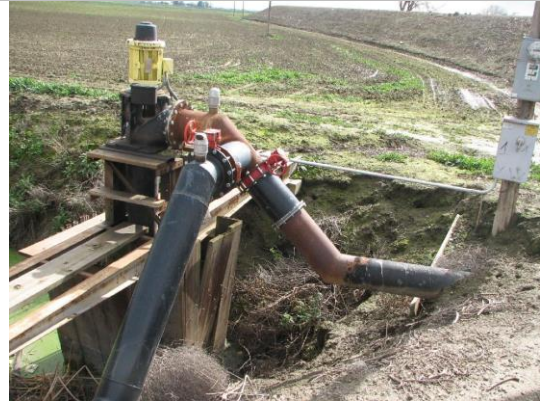
Photo 3 of 3 : UCIP\_SP\_2017\_49640\_74432.jpg

Pump, vent, butterfly valve, and pipe visible off LS toe.

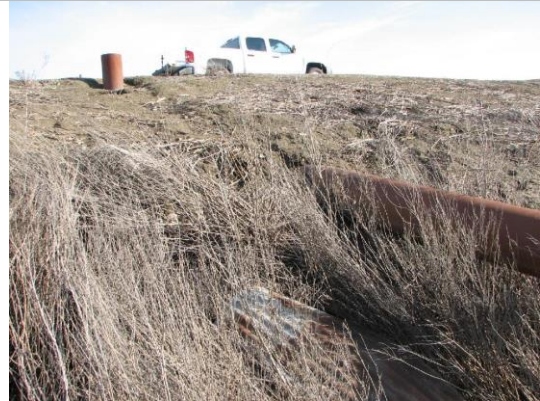
Photo 3 of 3 : UCIP\_SP\_2017\_49992\_38774.jpg

View of WS slope--riser and pipe visible.

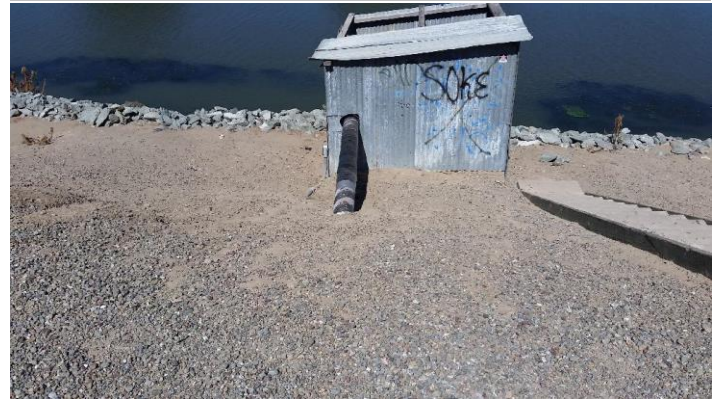
Photo 1 of 3 : UCIP\_SP\_2017\_50081\_75745.jpg

View of WS--slope cleared of vegetation.

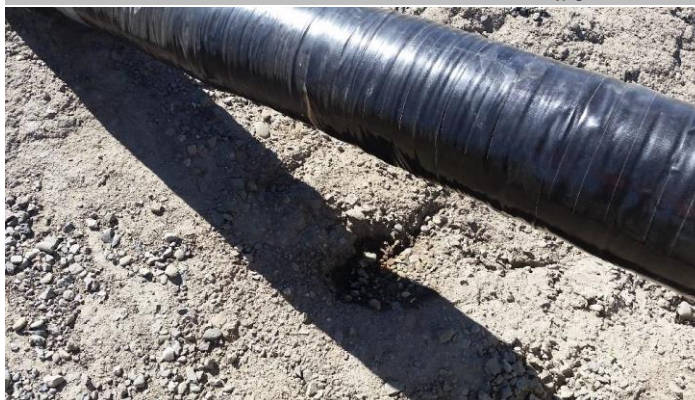
Photo 2 of 3 : UCIP\_SP\_2017\_50081\_75742.jpg

WS view--moisture observed on ground below wrapped pipe section, photo 1 of 2.

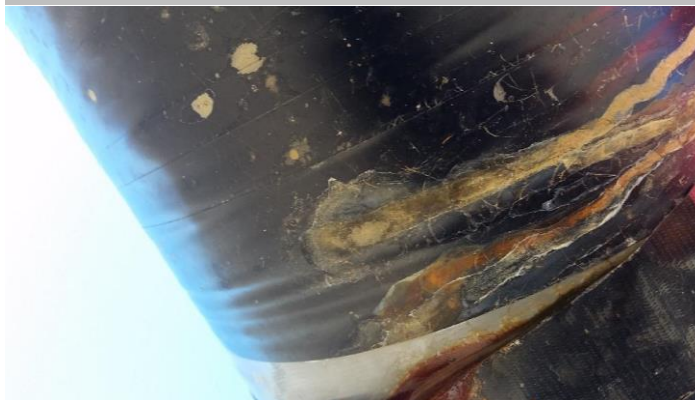
Photo 3 of 3 : UCIP\_SP\_2017\_50081\_75743.jpg

Pipe leak visible on WS pipe section, photo 2 of 2.

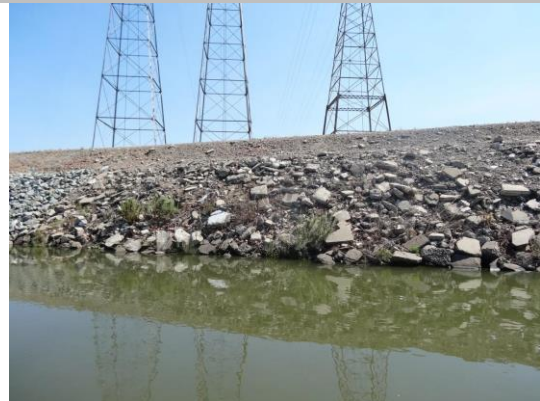
Photo 1 of 2 : SP\_2017\_RD0017\_304\_83\_20170316\_00009.jpg

Front view of the erosion.

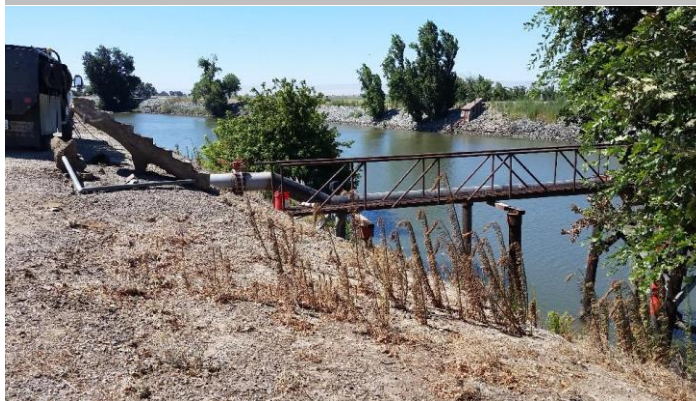
Photo 2 of 3 : UCIP\_SP\_2017\_50004\_75871.jpg

View of WS--coated pipe, walkway, and removal of concrete stairway. Construction in progress.

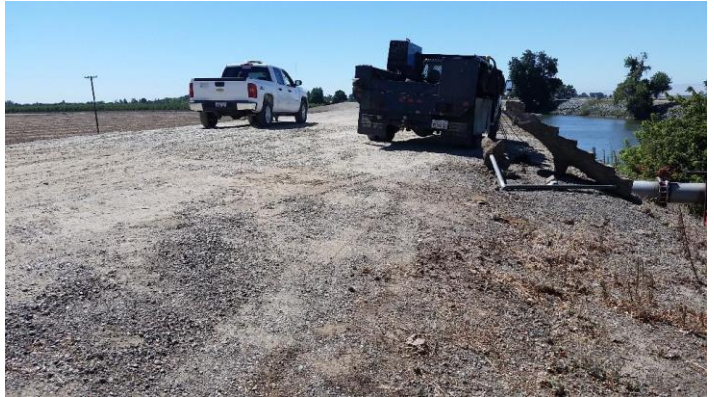
Photo 3 of 3 : UCIP\_SP\_2017\_50004\_75872.jpg

View of levee crown--construction on LS and WS in progress.

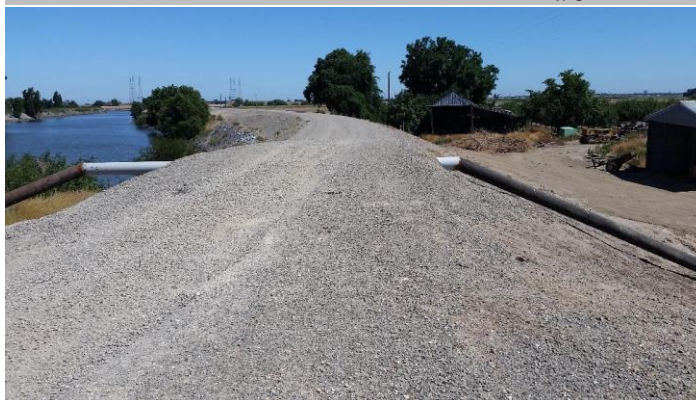
Photo 3 of 3 : UCIP\_SP\_2017\_50005\_75865.jpg

View of levee crown--levee section where pipe crosses is raised.

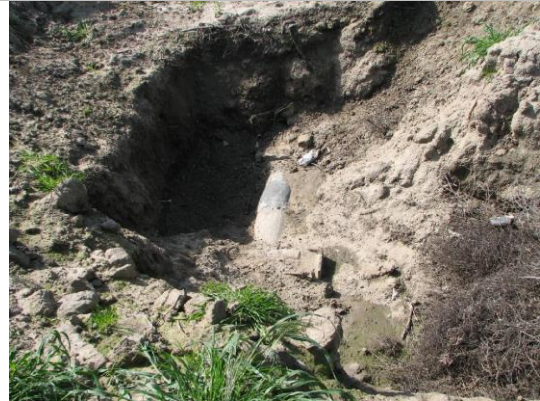
Photo 2 of 3 : UCIP\_SP\_2017\_49998\_72214.jpg

Section of levee slope exposed on LS.

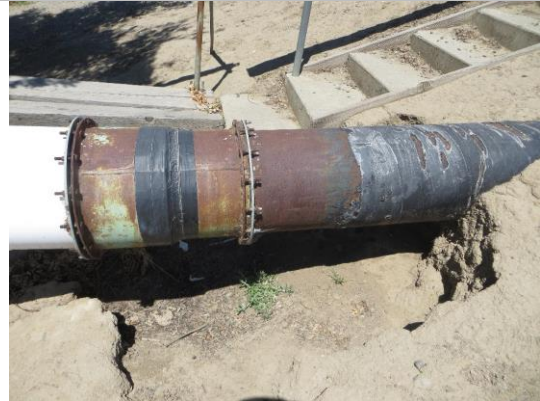
Photo 3 of 3 : UCIP\_SP\_2017\_45998\_74484.jpg

(2015) Erosion visible on waterward side.

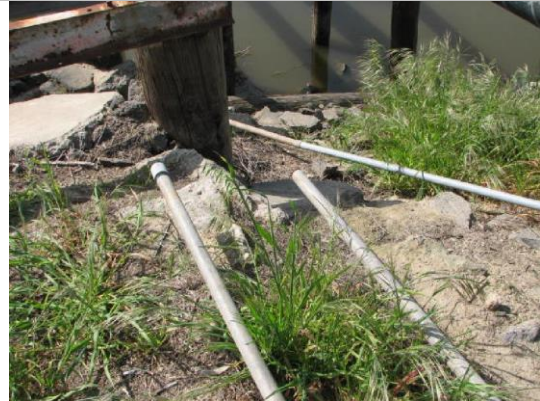
Photo 3 of 3 : UCIP\_SP\_2017\_40688\_72359.jpg

Conduits visible on waterward side--no connection.

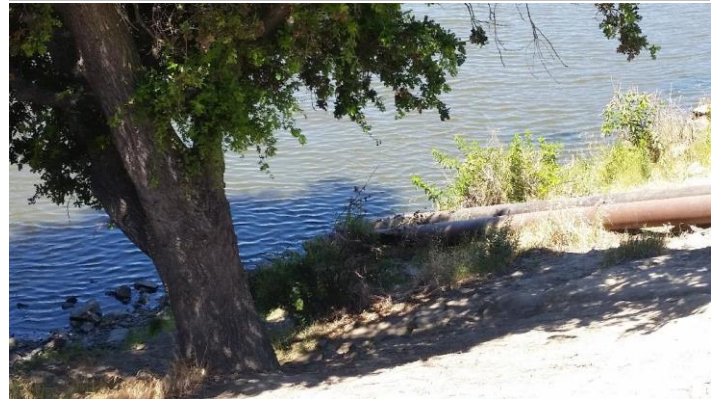
Photo 2 of 3 : UCIP\_SP\_2017\_49999\_75740.jpg

WS-pipe still damage, pipe wall section missing.

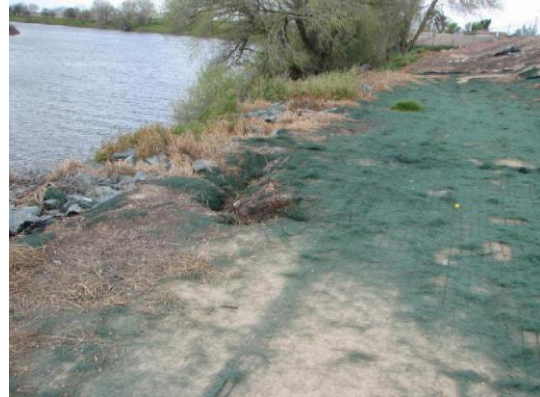
Photo 3 of 3 : UCIP\_SP\_2017\_40697\_72450.jpg

Surface erosion visible on waterward berm edge.

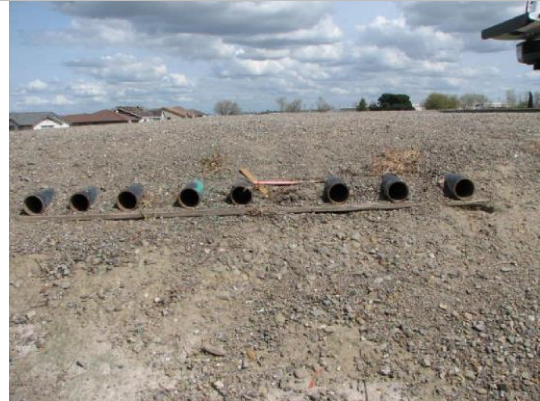
Photo 3 of 3 : UCIP\_SP\_2017\_45993\_72498.jpg

8-4 inch steel coated schedule 40 pipes with about 6 inch of cover.

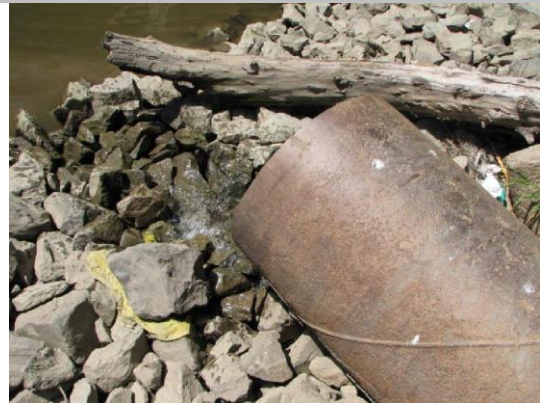
Photo 1 of 3 : UCIP\_SP\_2017\_45466\_72523.jpg

Pipe was running during field inspection.

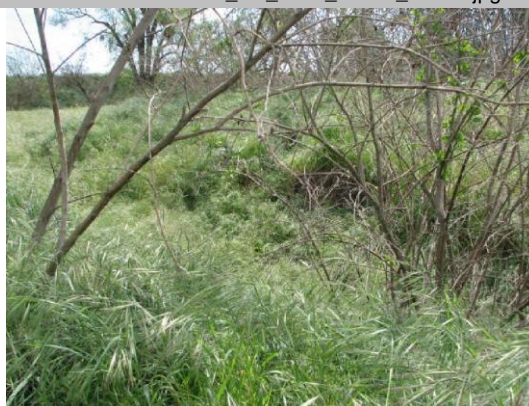
Photo 3 of 3 : UCIP\_SP\_2017\_40716\_72555.jpg

Scour hole located immediately upstream from crossing.
